TEST REPORT

Report No. RT12R-U0024-021-E

Name/Type of Product : Barrier 1 Tape
Sample ID No. : RT12R-U0024-021
Item No. : DTS-280A
Manufacturer/Vender : DUCKSUNG HITECH CO., LTD.

Sample Description : Barrier 1 Tape

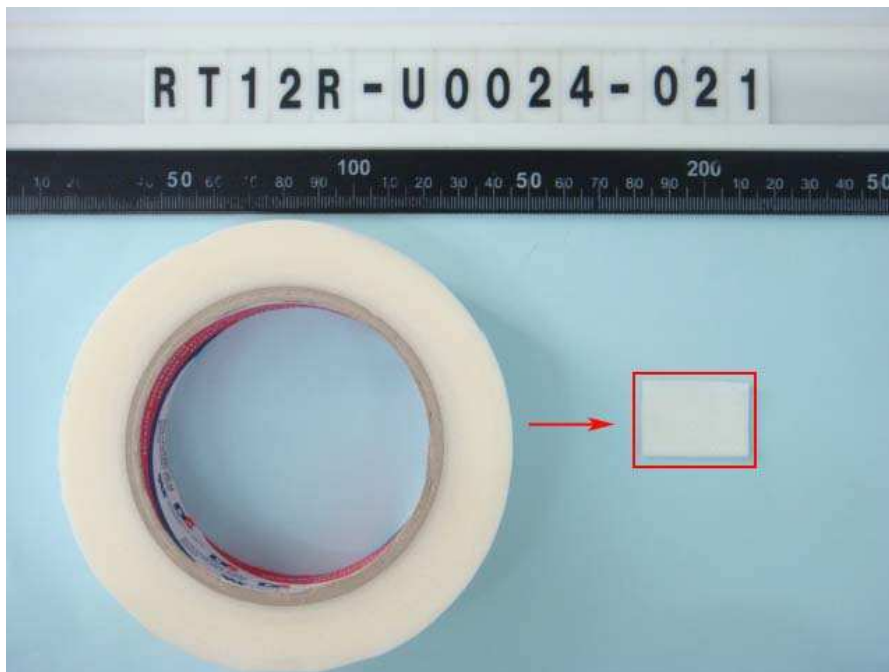
* View of sample as received;-

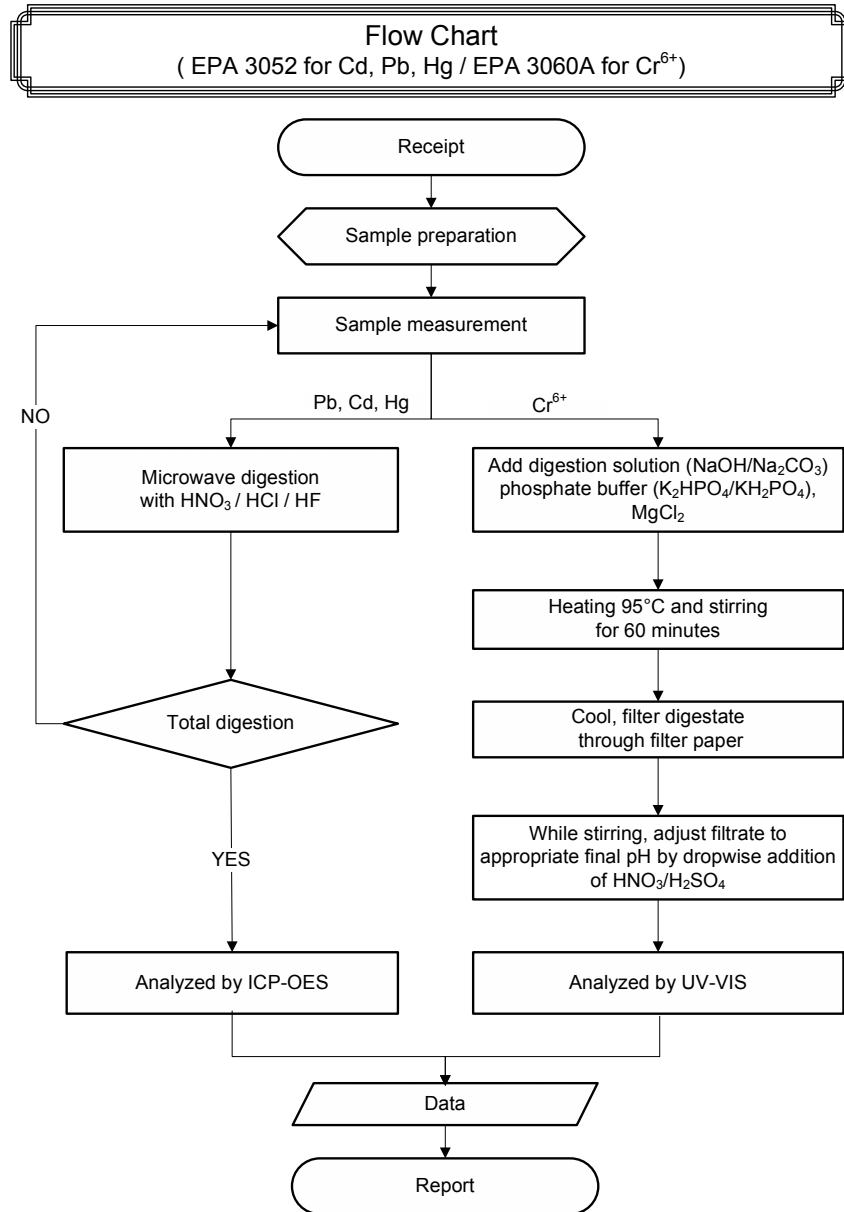
** Remarks : The samples were dissolved totally by pre-conditioning method according to above flow chart.
